**M11 Route Single Vehicle
Loss of Control Accident
Review**

**September 2008
Works Order No 97373**

Project Title: M11 Route Single Vehicle Loss of Control Accident Review
Report Title: Accident Study
Project No: 97373
Report Ref: 97373/01
Status: Final Report to Highways Agency
Client Contact Name: Steve Davy, Route Performance Manager
Client Company Name: Highways Agency
Issued By: Carillion-URS

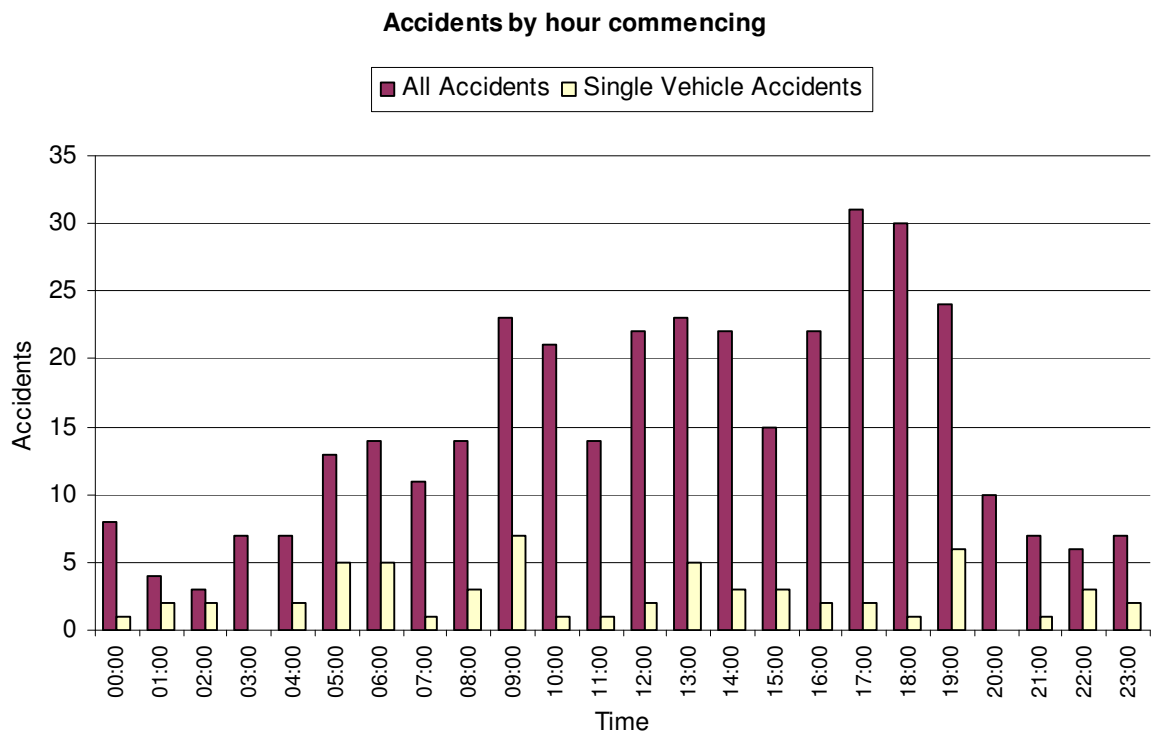
Figure 3.1 Comparison of accident times

3.6.6. Table 3.4 above illustrates that there is no particular day or time when these types of accidents are more likely to occur. However as seen in Figure 3.1 below, which shows all the accidents occurring within the study parameters against the single vehicle accidents, there is a more even spread, suggesting that the twilight hours see a higher proportion of single vehicle accidents. This can be explained by the lower traffic flows experienced at this time of day. It follows that a loss of control during peak hours (heavier flow conditions) is more likely to result in a collision with another vehicle than in the early hours when there is less traffic to collide with.
