Pilot study to assess the potential of selected existing structures on the A30 and A38 trunk roads to provide safer crossing places for deer.

Prepared by Jochen Langbein
Langbein Wildlife Associates

Deer Initiative Research Report 10/1
July 2010

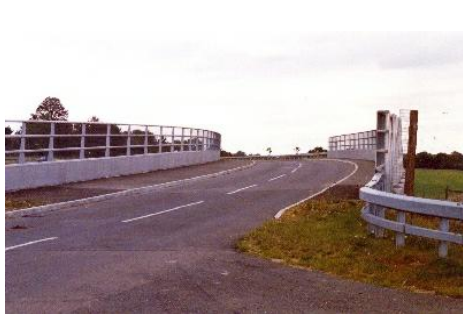
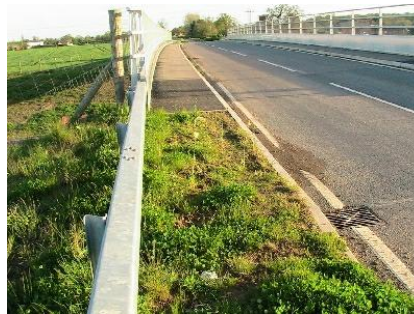
Photos 1 and 2: Examples of structures accommodating public road traffic leading over A120 Essex, known to be frequented by fallow and muntjac deer. Both structures cross over deer fenced sections of trunk road; base substrate for both is of concrete or tarmac throughout the main span. (Langbein, 2008)

2.12. It is interesting to note further that the A120 road bridges used by fallow (above) both had concrete or tarmac substrate without any strip of natural surface, although a natural substrate is widely reported as critical to achieve use by deer by many past studies. Another example of a concrete-only overpass used by fallow occurs over the M25 London orbital motorway at Copthall, Epping Forest. Fallow deer have been filmed crossing this 4 m wide and 85 m long concrete-only bridge (see Section 5: Photos 5 and 6), as well as regular deer movement across a slightly wider 7 m overpass which does have a part soil covered base (Langbein, 2007c). Further examples of joint use structures of modest size in England used by deer, include a roadbridge over the M40 near Oxford (Halcrow, 2002) which was provided with a grass and gravel verge to encourage wildlife, and use by red deer of an underpass and a narrow overbridge over the M6 Toll motorway (Cresswell pers. comm). In common with all the above examples these structures on the M40 and M6 also occur within sections of trunk roads provided with deer fencing.

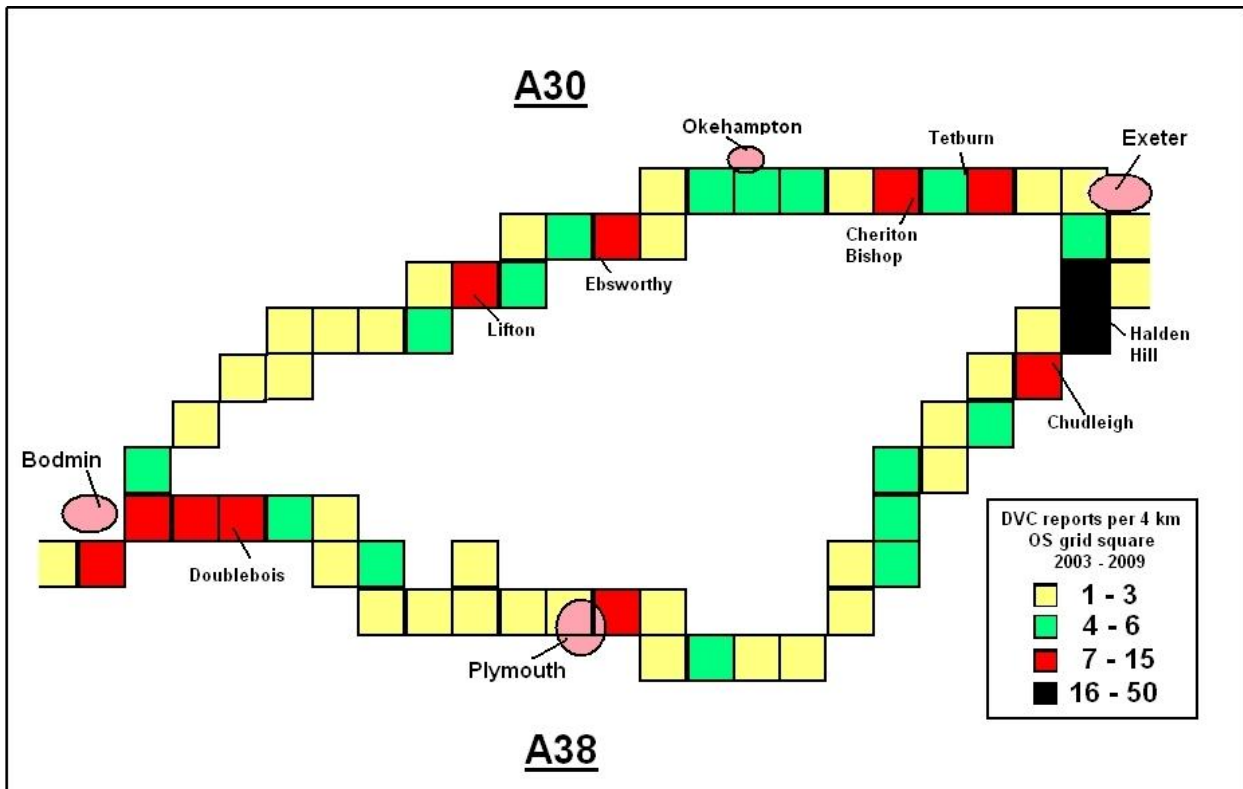
Figure 1: Relative distribution of deer road casualties and related vehicle collisions reported via the Highways Agency's Area 1 Control Centre for the A30 and A38 trunk roads between Exeter and Bodmin during 2003 to 2009 (346 incidents mapped)

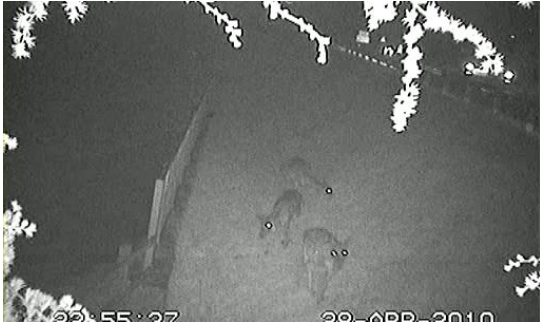
Photo 3: Freeze frame from video filming across top of Belvedere underpass with A38 trunk road on right. (for video clips see Appendix III)

4.34 Good footage of deer (readily recognisable as such) was obtained at one of the structures (Belvedere Cross). Here no fewer than at least seven different fallow deer were filmed, not seen moving through the structure itself, but recorded walking across the top of the underpass along the verge of the A38 trunk road. Several sequences filmed here show deer feeding calmly within just 2m to 6m of the main (eastbound) carriageway. Despite the close proximity of busy trunk road traffic, which on video footage can be seen passing in the background, groups of fallow deer filmed at night appeared to take little notice of the nearby traffic (see Video clip 1 – Appendix [IV], and freeze frame Photo 3 below). Several further fallow deer were recorded above the same underpass during daylight soon after dawn. Video Clip 1 shows deer grazing or slowly walking along the trunk road verge above the underpass for nearly 15 minutes, with heavy traffic passing alongside; Clip 2

shows deer walking up the embankment in daylight, within just one metre of the edge of the structure and the road below. The video recordings and presence of very extensive deer slots and dung found along the verges (Photos 4148 - 4151) indicate that fallow use these areas very commonly as a normal part of their home range. That is, approaches by the deer onto the trunk road verges at this location appear to occur mostly not with intention to actually cross the main road, but to feed on the verge or move across the side road. The regular exposure to the flow of road traffic closeby is likely to lead the local deer to become increasingly habituated to the noise of approaching vehicles, and possibly less cautious of crossing into the traffic at other times.

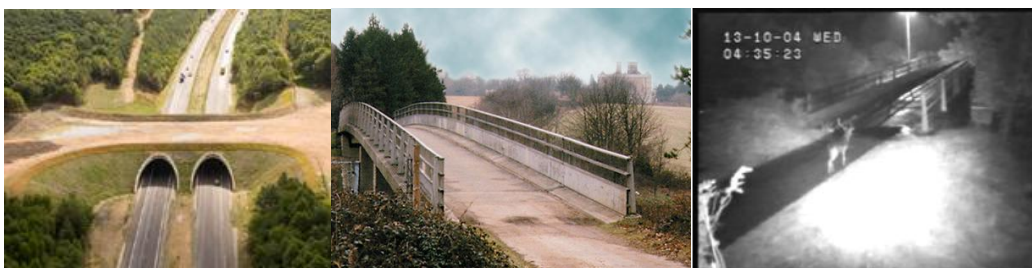
Photos 4, 5 and 6: A large green habitat bridge in Switzerland (left) and a narrow joint use bridge with concrete substrate across M25 nr London (centre & right): each structure was designed for a quite different set of aims but both are regularly used by deer.

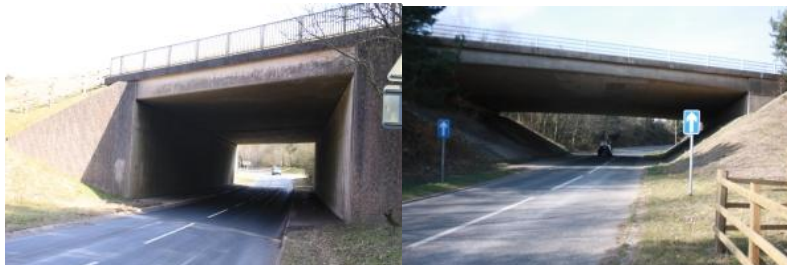
Photos 3452 and 3465 – Underpasses beneath A38 at Belvedere Cross (left) and Harcombe Cross (right)

5.22 In case of Belvedere Cross underpass it seems very likely that movements of fallow deer through this underpass could be attained (or increased if already occurring to a limited extent) through installation of a number of short length of fencing. The latter would require careful design lay-out to ensure minimal risk of deer entering the inside of the fenced section through end-runs and maximise its use to deter deer from crossing the trunk road. The opportunity may also exist in this area for possible use of less than full-height deer fencing or fencing erected on the slope of existing embankments that would enable deer to cross in one direction but not another. If such adaptation is found practical after closer investigation and resources are available, some systematic pre and after monitoring of deer use and behaviour around the underpass should be included as part of the scheme, ideally using CCTV equipment or else alternative methods alongside continued monitoring also of deer collisions, in order to assess the actual effectiveness and cost effectiveness of adaptations undertaken.

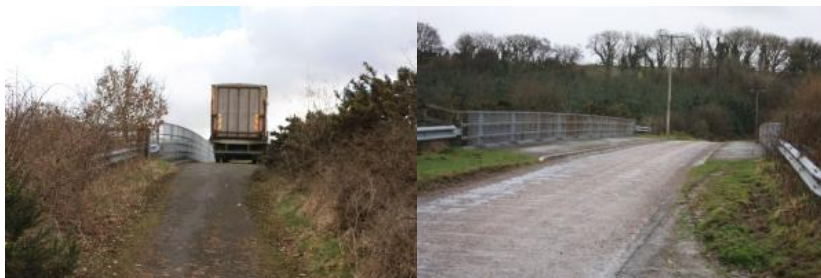
Photos 4110 and 4096 – Overpasses over A30 at Ellacott Farm (left) and Ebsworthy Farm (right)

5.25 Ellacott farm overpass (Photos 4111; 4119) is a narrow farm accommodation bridge free of any road traffic and only occasional farm vehicle access. At the time of survey a lorry had been parked continuously on the structure for several months, blocking much of the path (Photo 4111) , whilst a metal gate and piles of silage bales block much entrance onto the structure from the south. Signs of deer were found within less than 50 m on the northern side, though no signs noted directly on the (hard substrate) bridge itself. Although this overpass is only 4m wide, it is very favourably located to serve as a deer crossing in a very quiet area where Ebsworthy wood and a new tree plantation abut closely to its northern side and pasture fields to the south. The main adaptation suggested in this instance would centre around removal of current obstacles to deer use of the structure; i.e. by ensuring no farm vehicles or other machinery are parked long-term on the structure in future, and other obstacles such as silage bales and gates are removed to enable freer passage for deer and other wildlife. Stock fencing adjoining the structure especially on the southern side should also be adapted in a way that enables ready access by deer. In addition, consideration should be given to improvement of the woodland / trunk road boundary fencing for the c. 2 km section located between the two overpasses, to help channel deer to the safer crossing places and prevent them crossing over the trunk carriageways in this area.

5.26 Ebsworthy Farm overbridge is a somewhat wider (7 m) overpass carrying a minor road / lane (e.g. Photo 4096, 4102) with very light local traffic flow. Woodland abuts within 75m on the southern side, with pasture and moorland to the north. Signs of red deer activity were found within 75m of the entrances, and although no direct evidence of deer crossing activity was noted during the short pilot survey, it seems likely that deer may already use the bridge to some extent. The
